Friends of the Choo-Tjoe

The Loop

NEWSLETTER NUMBER 12 – FEBRUARY 2014

Carriage restoration.

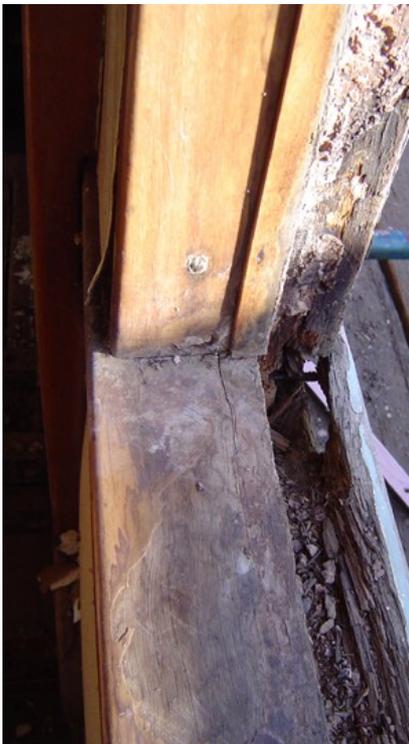
The rotten centre rail

The first problem was the dry rot in the centre rail of the dining car (SHASHI). There was no chance of patching this particular piece so it was cut out over a distance of about twelve feet. As luck would have it, there were several old coach bodies awaiting scrapping and these yielded up a good quantity of well seasoned teak (80 years old!) From this a new section was formed and duly inserted into the carriage.

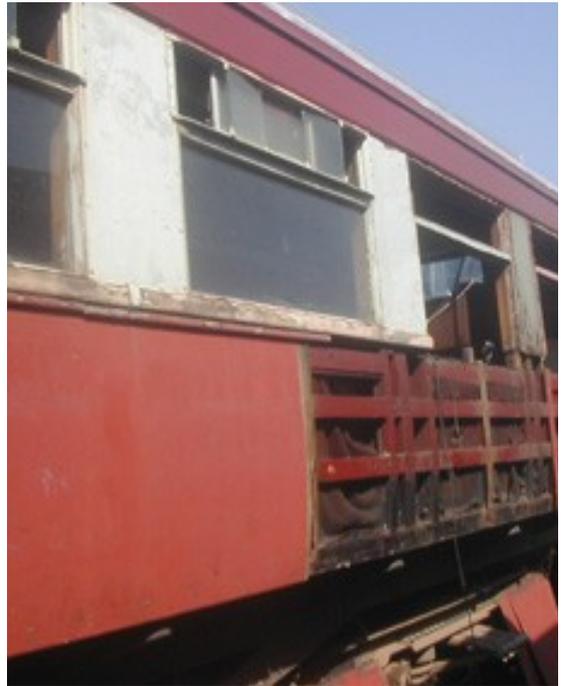
The old rail removed

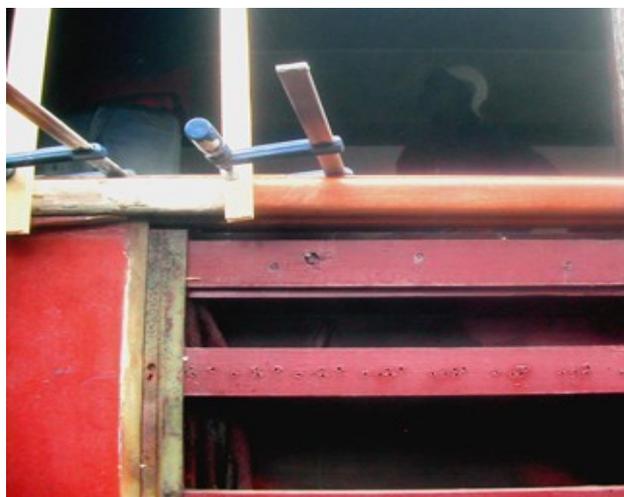
New rail spliced in

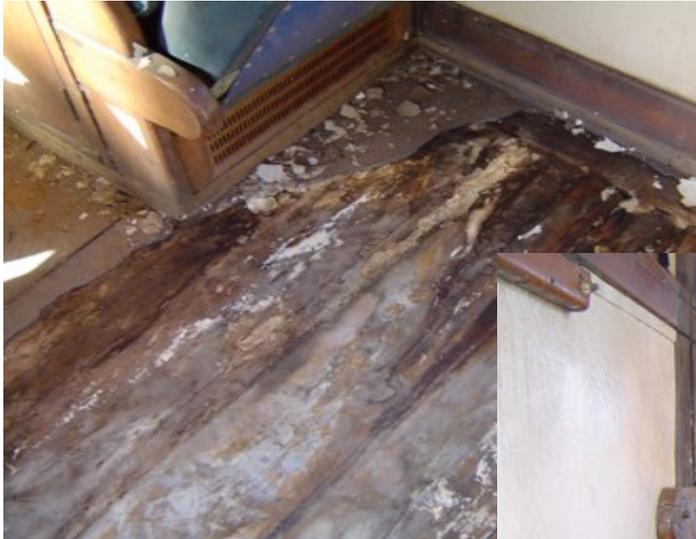
Wet rot in floor

It was then discovered that the floor was also riddled with wet and dry rot. The floor was removed in sections and replaced with best bongowood, well treated and coated in creosote. The main frame of the carriage was teak and this fortunately had escaped the rot. It too was well treated before the boards went down. The boards were delivered from SA Timber, cut to size; except they weren't! So a considerable amount of planing had to be done before they were laid down. Another problem was that if they were not immediately screwed down, they took on the shape of bananas or barley sugar twists. Much use was made of wedges and large hammers!

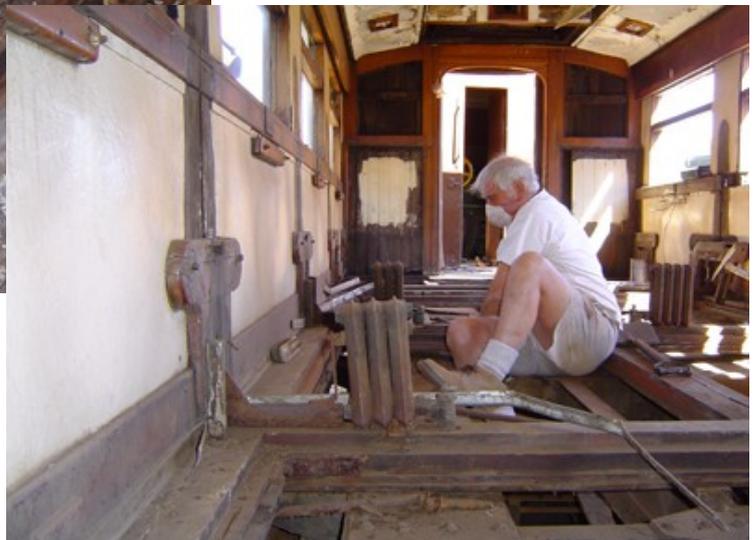
Removing the old floor

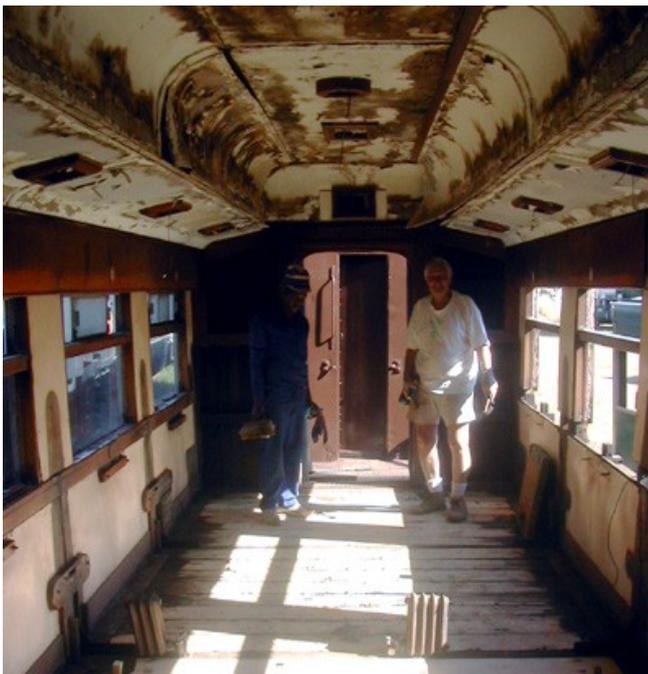
The new floor goes in

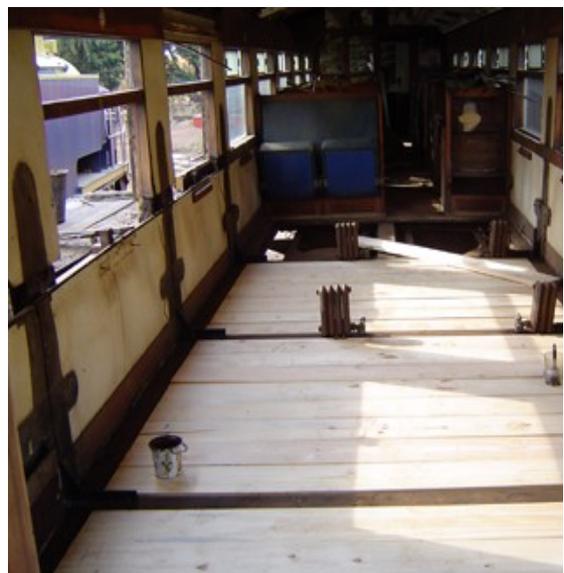
The new floor

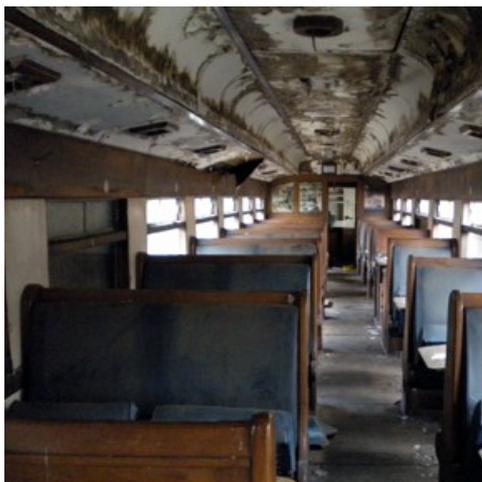
the rotten ceiling

The next task was to remove the ceiling which was soaking wet. The decorative hardwood trim was first removed (where it had not already fallen off) and then the ceiling panels were removed, again in sections. Once all the old screws and nails had been removed, any rotten timber was replaced and the whole lot treated.

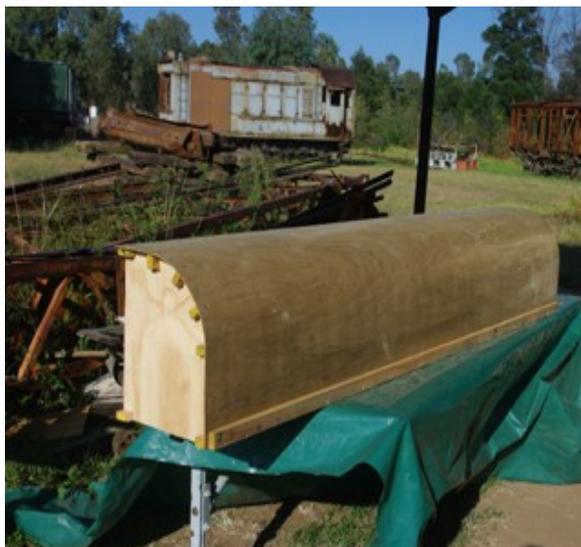
The former

To make up the new ceiling panels, several formers had to be made. The method for producing the panels was to take two sheets of hardboard, wet one of them and wrap it round the former. When this had dried in it's new shape, the other piece was similarly treated. The two halves were then coated in glue and clamped up to the former until they were dry. This produced a curved piece which could then be cut to size and attached to the ceiling.

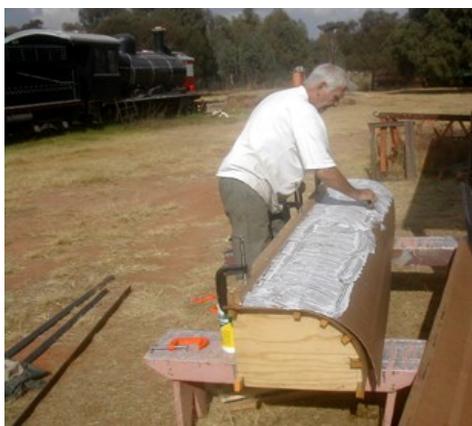
Glueing up the panels

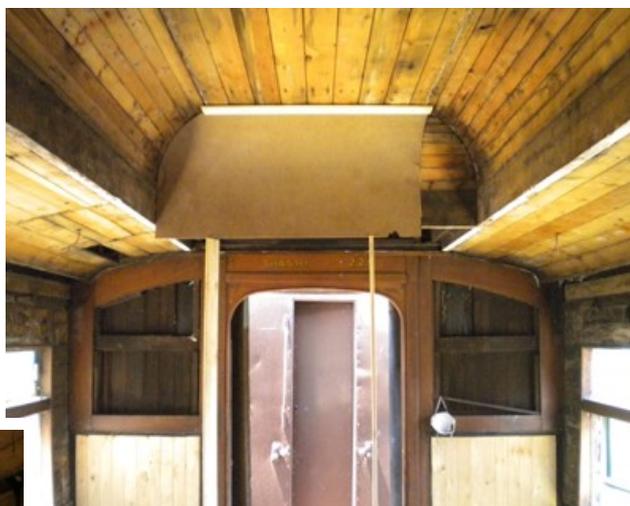
Preparing the template

The tricky bit was where the end met the side. Here there was a compound curve and a template was produced using a thin piece of hardboard, sprung into place and trimmed until it fitted. This template could then be laid on the required panels and the panels marked out for cutting. Once the lads had got the hang of it, there was no stopping them and thoughts could turn to other problems.

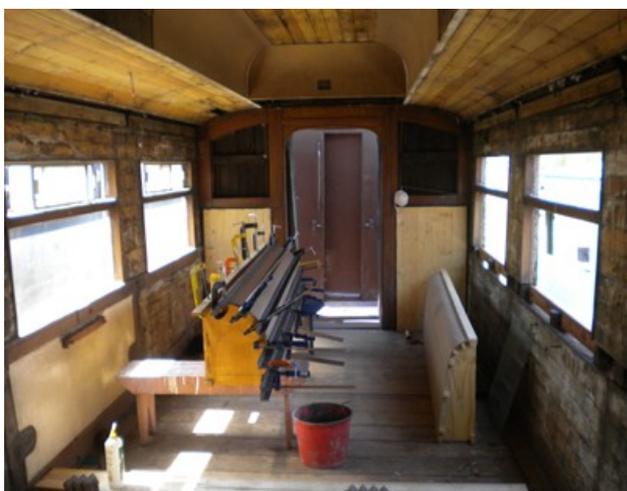
Installing the ceiling panels

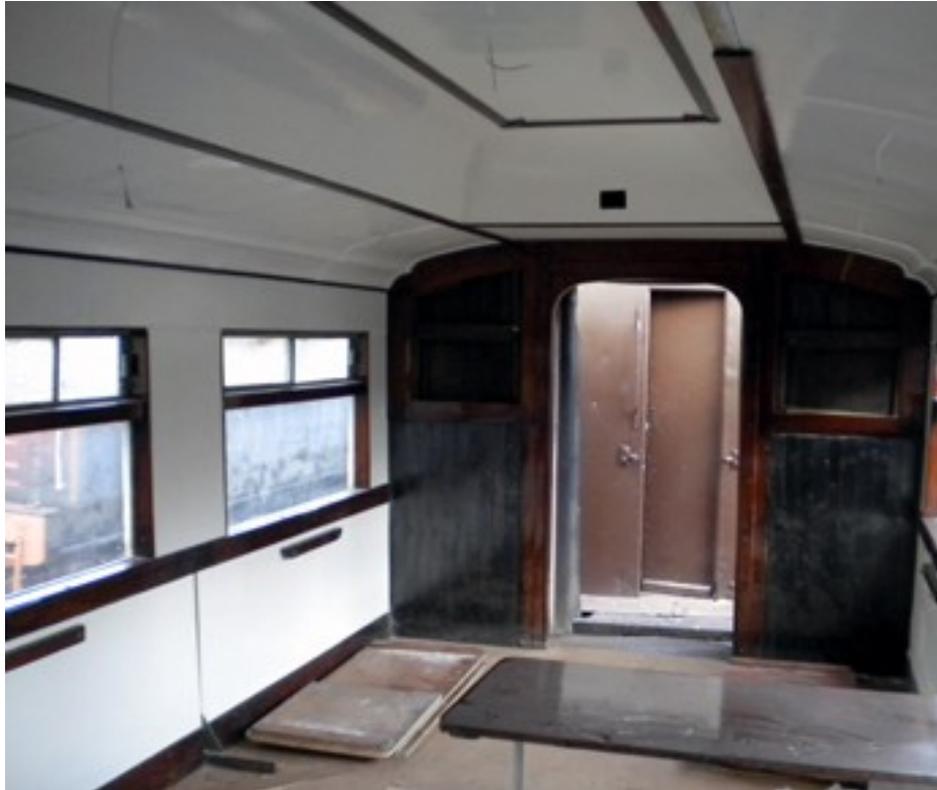
New ceilings and wall panels with the restored trim being replaced
