Friends of the Choo-Tjoe

NEWSLETTER NUMBER 16 – JANUARY 2015

Carriage restoration continued

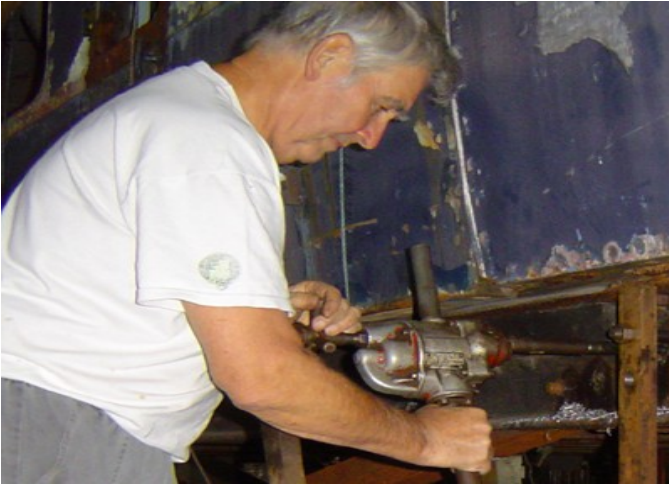
Drilling the truss rods

Small holes were drilled through the trusses and the queen posts and all four were bolted together. The same procedure was adopted to bolt the trusses to the main frame. The next task was to rivet the ends of the trusses to the mainframes. With the trusses firmly clamped to the frames, the old holes in the frames were used for guiding the drill through the trusses. Bolts were used to secure the frames and the trusses together. This process was repeated until all four truss ends were drilled out.

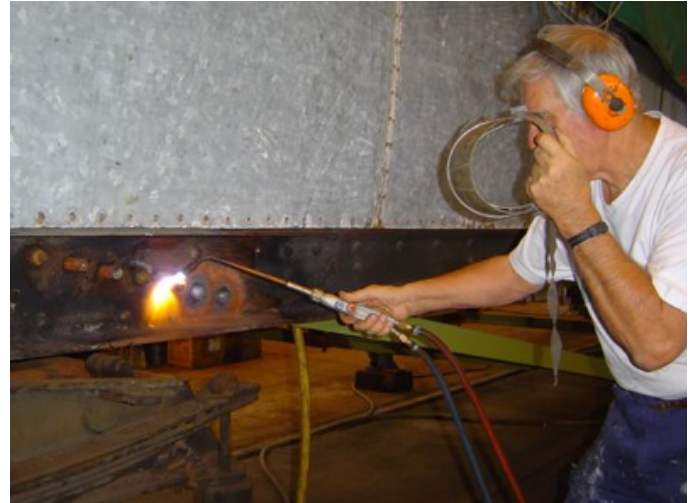
Heating up the rivets

The following day we started riveting. Having double checked all our measurements, we started by riveting the queen posts to the frame, replacing bolts for rivets.. This was particularly awkward as the area to be riveted was tucked up under the body. Next the trusses were riveted to the frames. Sounds easy, but neither of us had ever done any riveting before. Normally rivets would be heated up in a furnace until white hot before being hammered over. We had to use an oxy acetylene muffler to heat up the rivets and of course, they usually cooled down before a good joint was made. So it took several heatings to get them hammered home properly. Next the four vees were welded up and the queenposts were riveted to the trusses. By the end of the day, we had a rigid underframe.

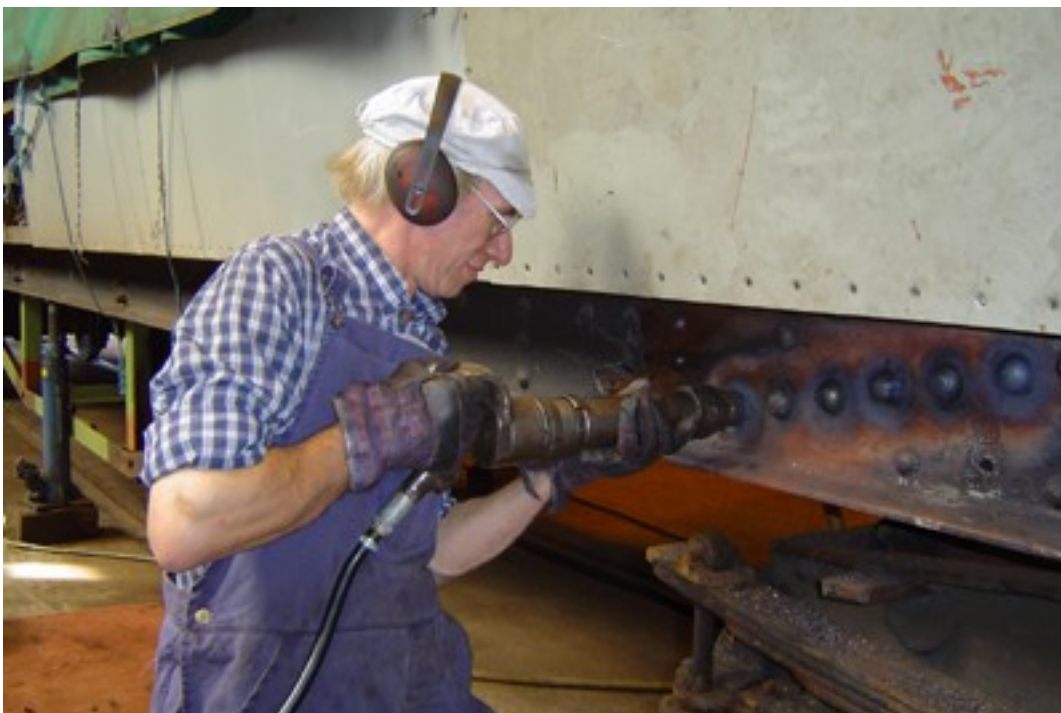
Hammering the rivets

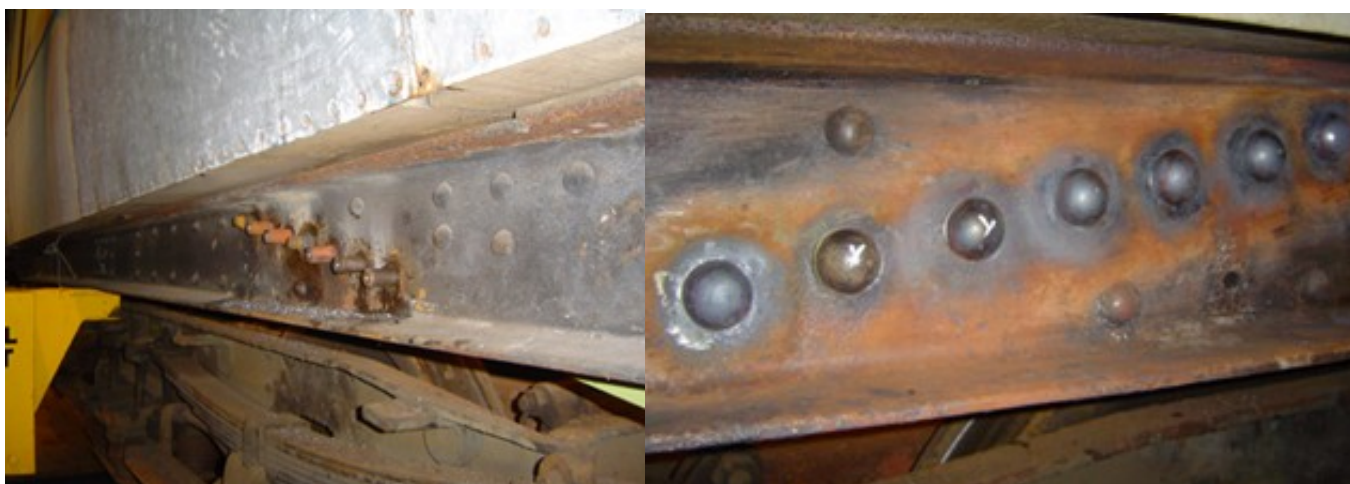
Rivets in place

Rivets hammered over

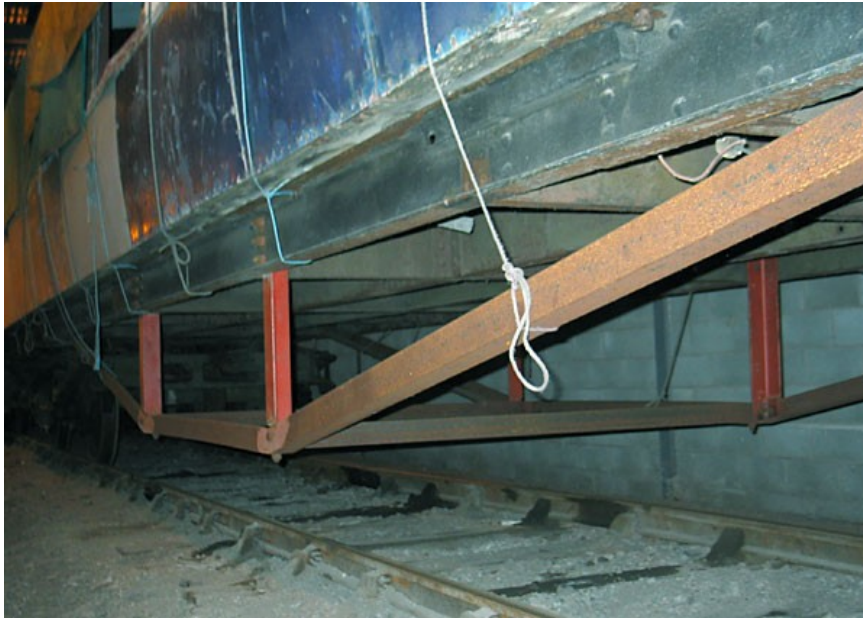
Completed trussing

The first job was to replace the four queen posts and once this was done, the carriage could be levelled with enough clearance for the trusses themselves. This was done using the carriage jacks at each corner. To allow for deflection in the centre from the full weight of the body, the underframe was lifted by one inch during the riveting process. The truss rods were then placed in position under the queen posts and a vee was marked in the four positions where they were to be attached to the queen posts. The trusses were then removed and the four vees were cut. They were then replaced in the correct positions and clamped up. Heat was applied to the area round the vees and the trusses were raised at the ends until the vees met. The bent trusses were then clamped to the main frames.

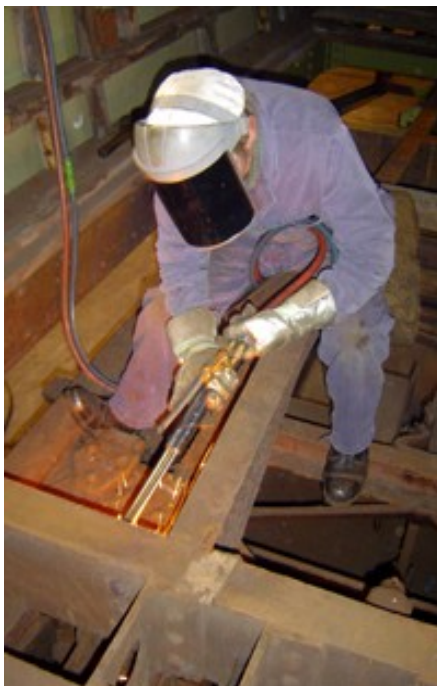
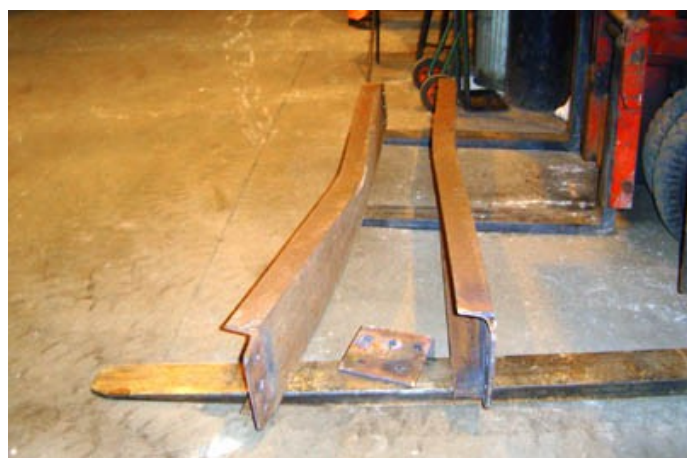
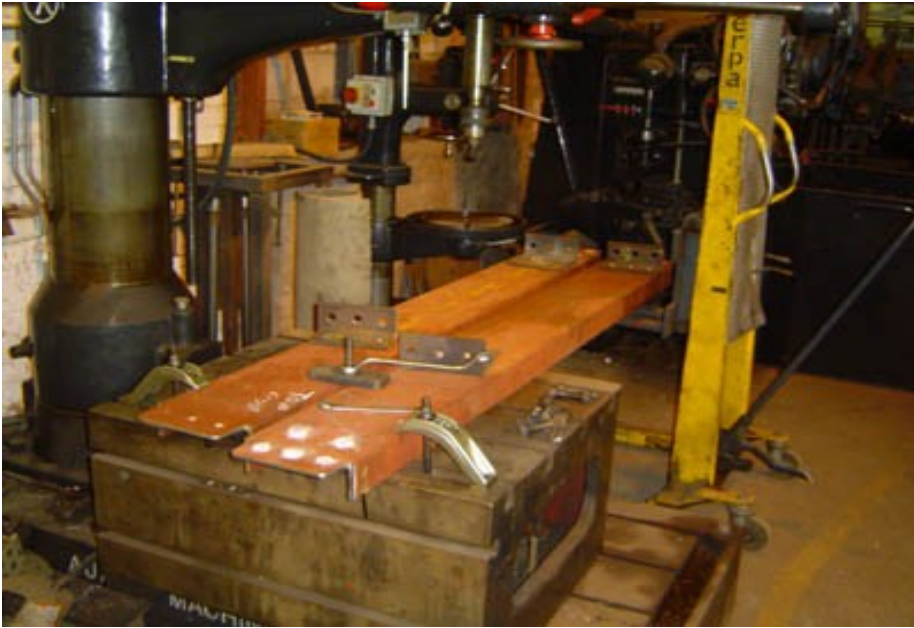
Cutting out the bent longitudinals and the new ones on the drill

When the carriage had been slewed onto the trailer, a couple of the longitudinal braces had been bent. These were cut out and new ones were made using the old ones as patterns. In addition to this, quite a lot of the steelwork that held such things as battery boxes and brake gear had been cut off when the carriage had first been slewed onto the platform all those years ago. This all had to be replaced some from stock but quite a lot made from new steel.
